ON-SITE GUARDRAIL GARDEN TRAINING

FLEAT-MT End Treatment Component Checklist

FLEAT-MT Inspection Checklist

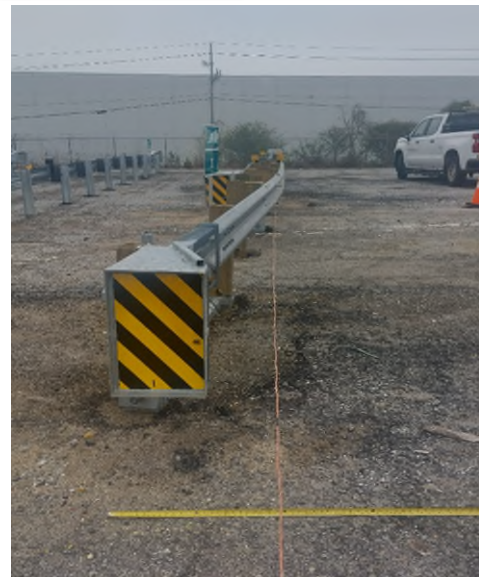
1. Is the rail at post 1 placed at a straight, single-sided flare offset of 2'-0" beginning at post 4?

Answer: Yes / No (circle answer)
Correct Checklist Answer: Yes
Manufacturer Checklist Item: #2
The rail at post #1 is placed at a straight single-sided flare offset 2'-0" beginning at post #4.

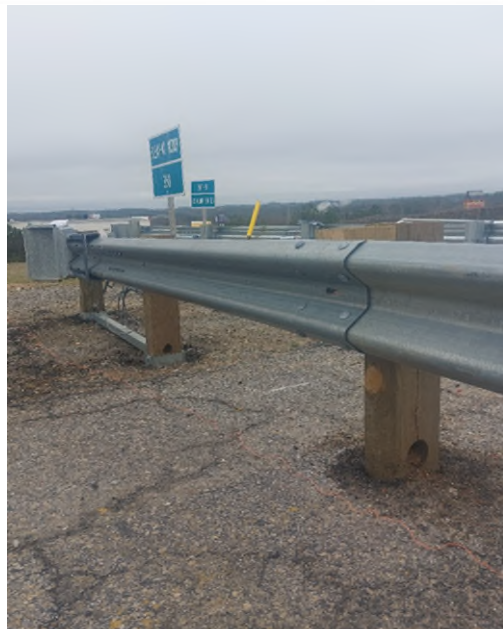
Answer: Yes / No (circle answer)

Correct Checklist Answer: No

Manufacturer Checklist Item: #3

The rail is not attached to the post at post location #3 or post location #1.

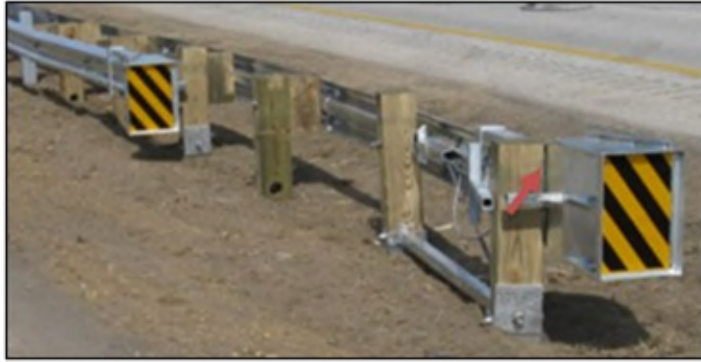
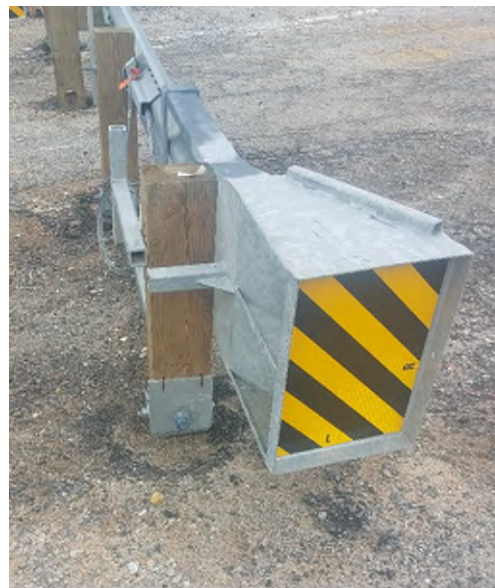
3. Is the rail attached to post 1?

The rail is not attached to the post at post location #3 or post location #1.

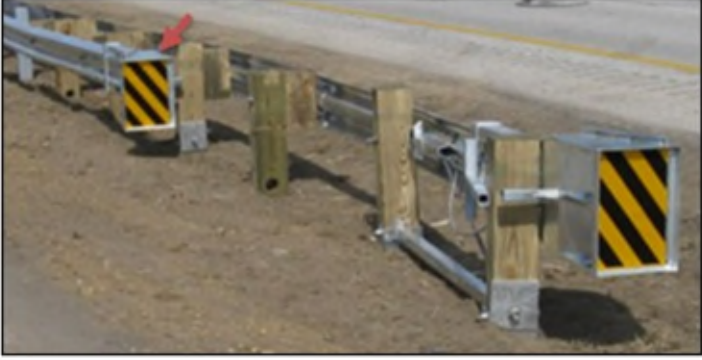
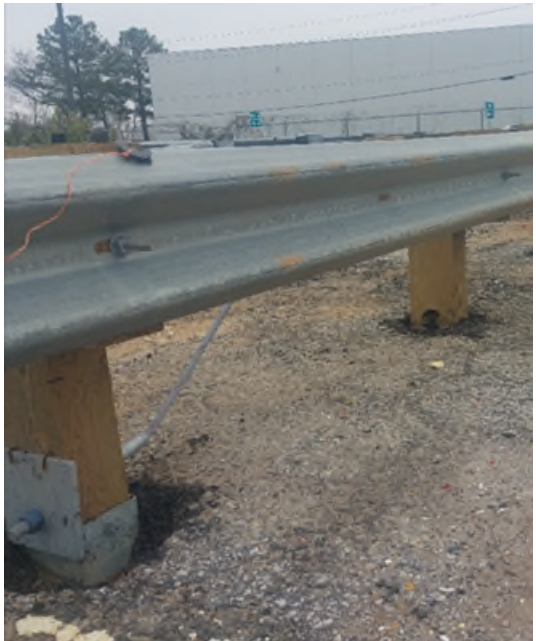
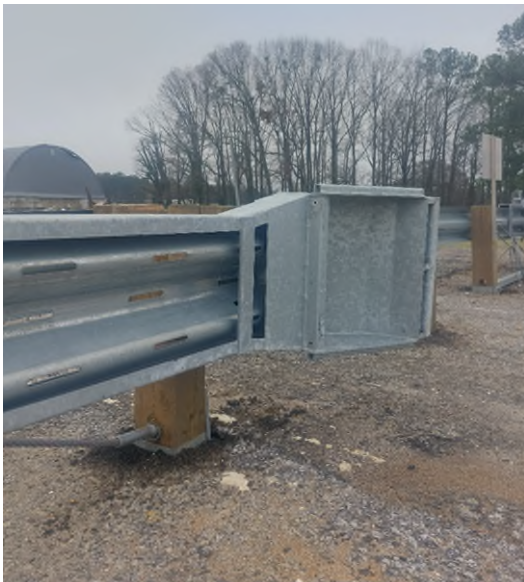
FLEAT-MT Inspection Checklist
	4. Is the rail attached to the post at the impact head side at post 4?

Answer: Yes / No (circle answer)
Correct Checklist Answer: No
Manufacturer Checklist Item: #4
The rail is not attached to the post at the impact head side only at post location #4.

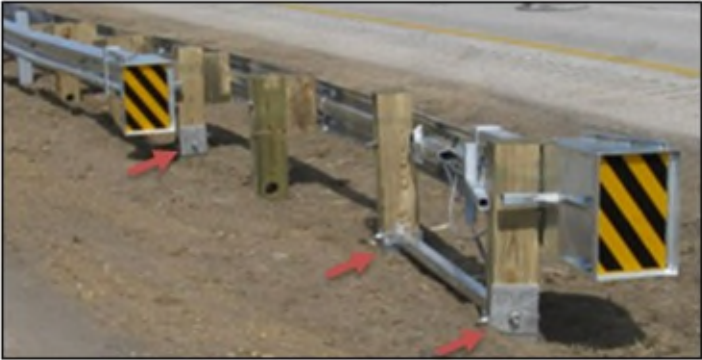
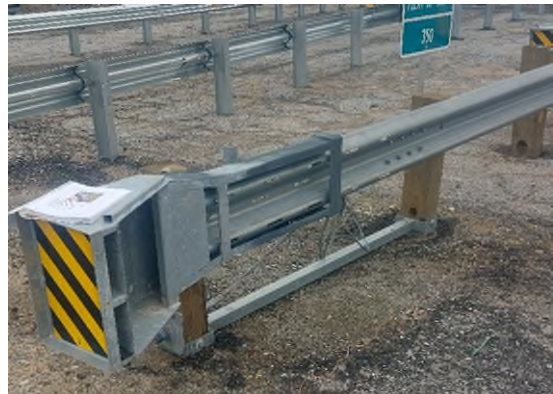
FLEAT-MT Inspection Checklist
	5. Do the 3 foundation tubes protrude more than 4" above the ground line? (Measured by the AASHTO 5' cord method)

The (3) foundation tubes do not protrude more than 4" above the ground line (measured by the AASHTO 5' cord method). Site grading may be necessary to meet this requirement.

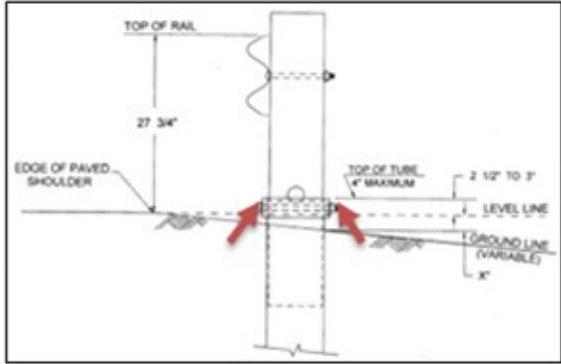
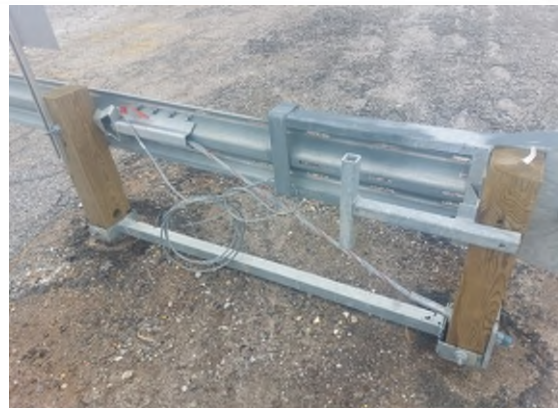
FLEAT-MT Inspection Checklist
	6. Are the bolts at the top of the 3 foundation tubes over-tightened, deforming the walls of the tubes?

The bolts at the top of the (3) foundation tubes are not over-tightened, deforming the walls of the tubes.

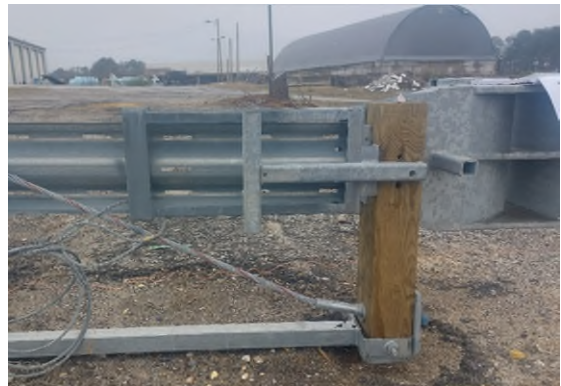
FLEAT-MT Inspection Checklist
	7. Is the guide chute of the 2 impact heads parallel to the top of the rail?

The guide chute of the (2) impact heads are parallel to the top of the rail and the exit slot of the impact heads are facing traffic.

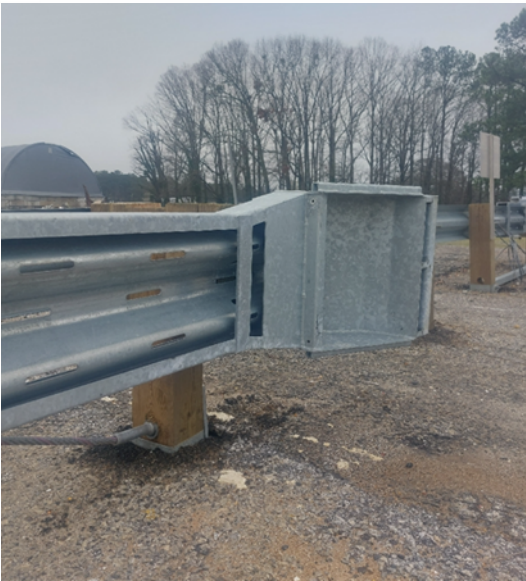
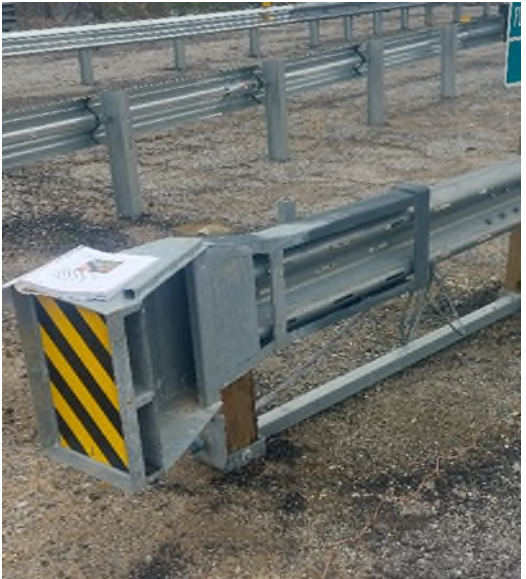
8. Are the exit slots of the impact heads facing traffic?

The guide chute of the (2) impact heads are parallel to the top of the rail and the exit slot of the impact heads are facing traffic.

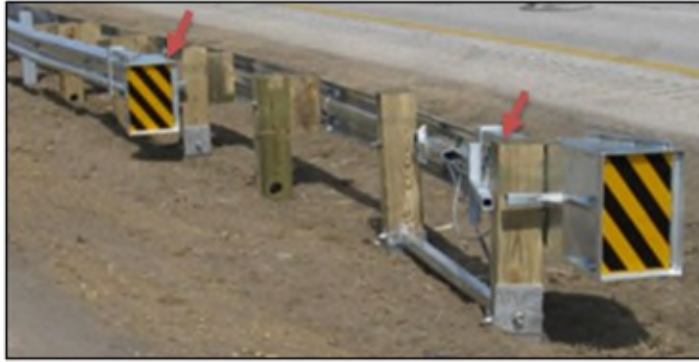
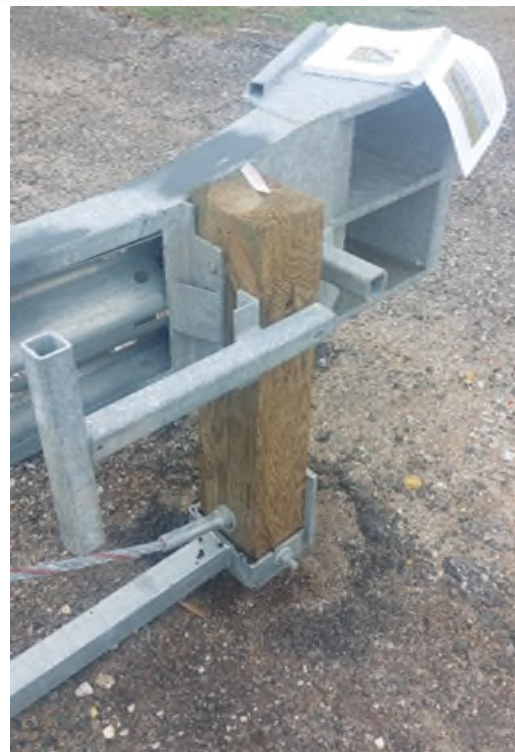
9. Are the two lag screws holding the impact heads to post #1 and post #4 snug?

The two lag screws holding the impact heads to post #1 and to post #4 are snug.

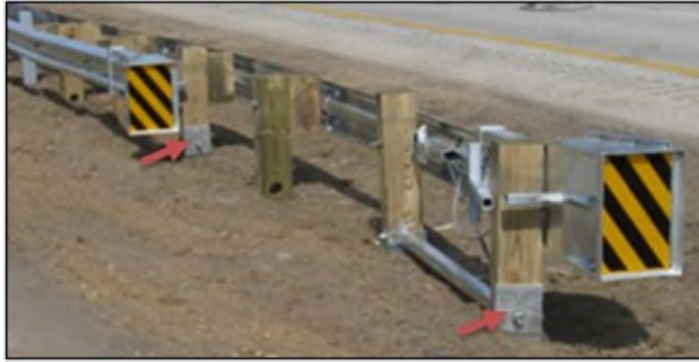
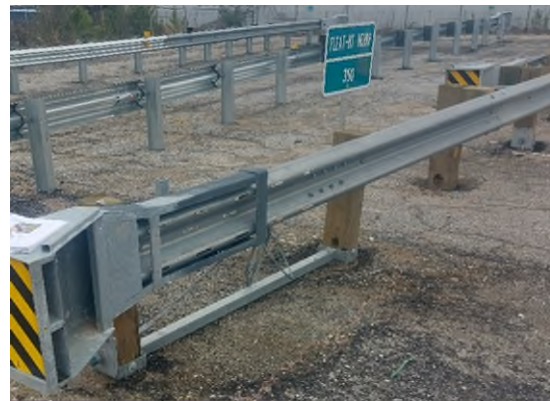
10. Are the 8"x8" bearing plates at post 1 and 4 correctly positioned with the 5" dimension up and the 3" dimension down?

The 8" x 8" bearing plate at post #1 and #4 are correctly positioned with the 5" dimension up & the 3" dimension down.

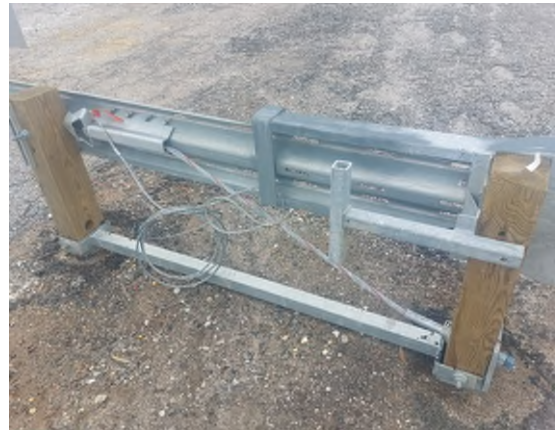
The anchor cables are taut and correctly installed.

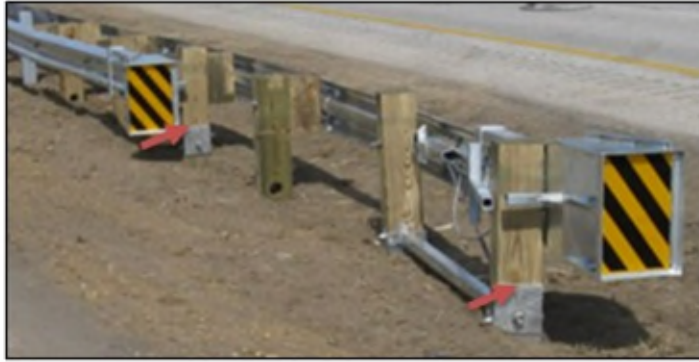
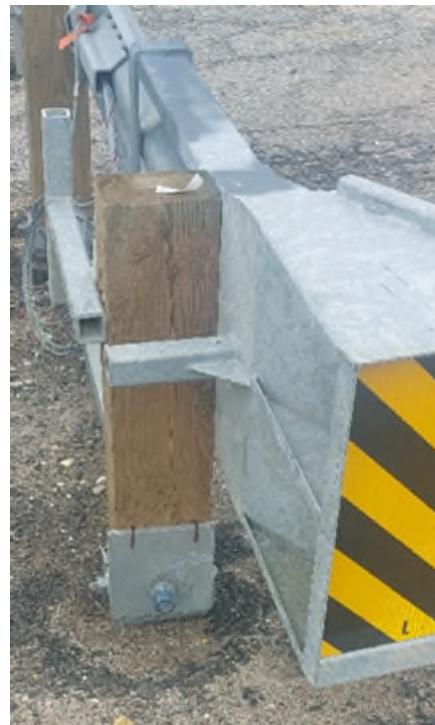
12. Has a nail has been placed over the bearing plates to prevent rotation?

A nail has been placed over the bearing plates to prevent rotation.

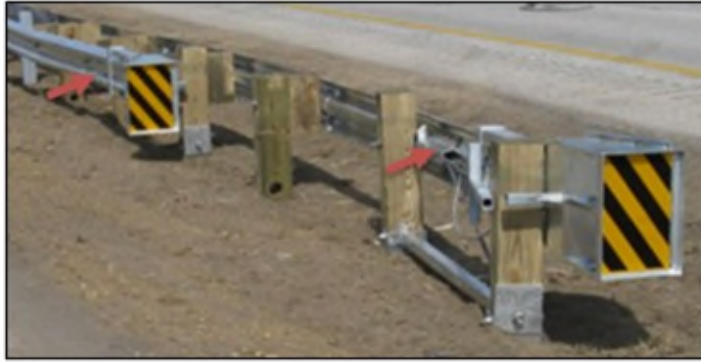
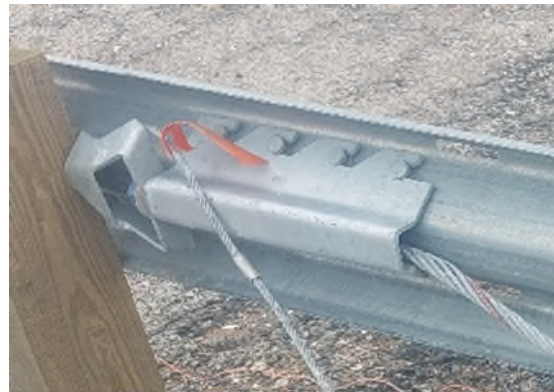
13. Are the cable anchor bracket shoulder bolts properly attached to the 2 W-beam guardrail end sections?

The cable anchor bracket shoulder bolts are properly attached to the (2) W-beam guardrail end sections.

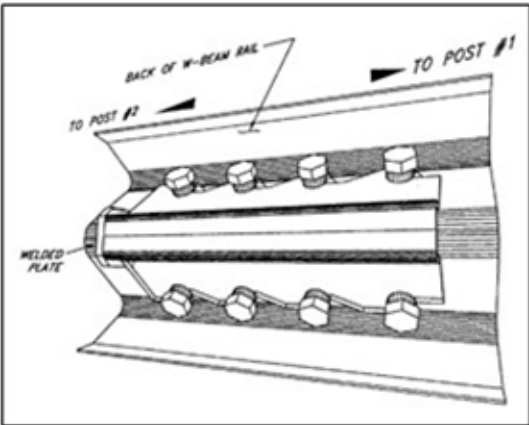
FLEAT-MT Inspection Checklist
	14. Are the cable anchor brackets fully seated on the shoulder portion of the bolts?

The cable anchor brackets are fully seated on the shoulder portion of the bolts.

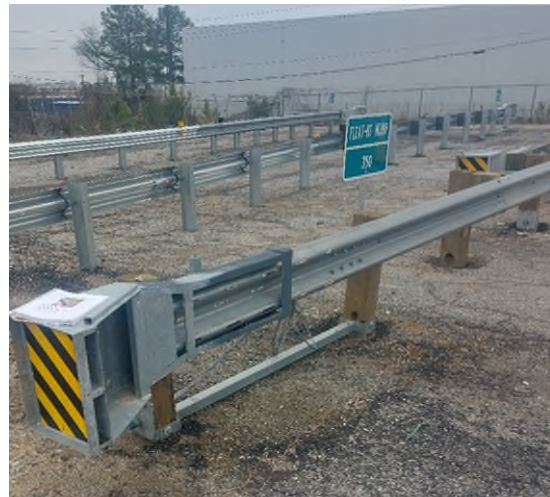
15. Are posts 1, 2 and 4 are installed in foundation tubes?

Posts #1, #2, and #4 are installed in foundation tubes and have the 2-1/2" breakaway hole located parallel to the roadway with the bottom of the hole at the top of the tube.

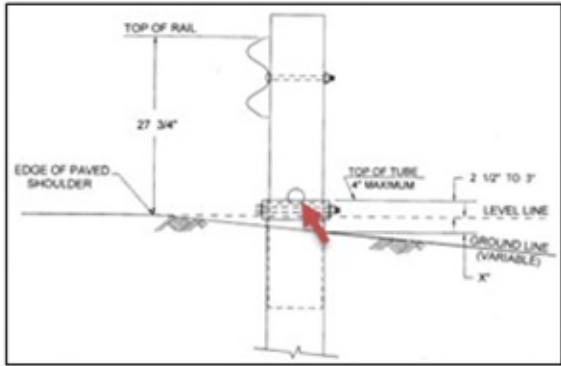
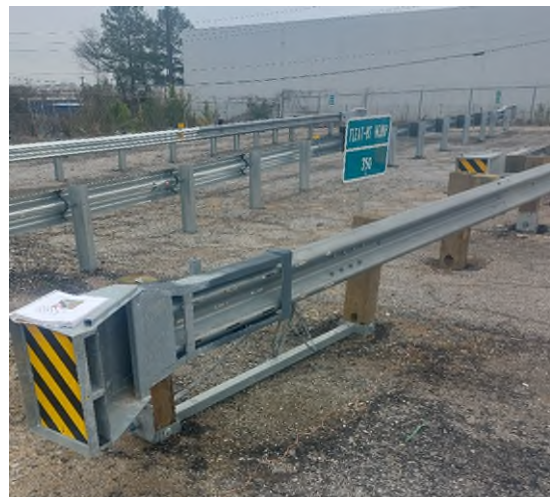
FLEAT-MT Inspection Checklist
	16. Do posts 1, 2, and 4 have the 2-1/2" breakaway hole located parallel to the roadway with the bottom of the hole at the top of the tube?

Posts #1, #2, and #4 are installed in foundation tubes and have the 2-1/2" breakaway hole located parallel to the roadway with the bottom of the hole at the top of the tube.

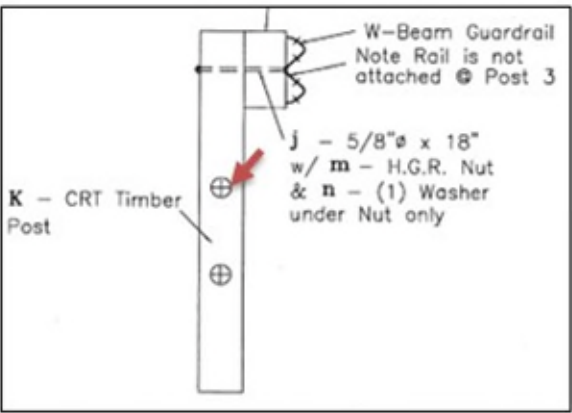
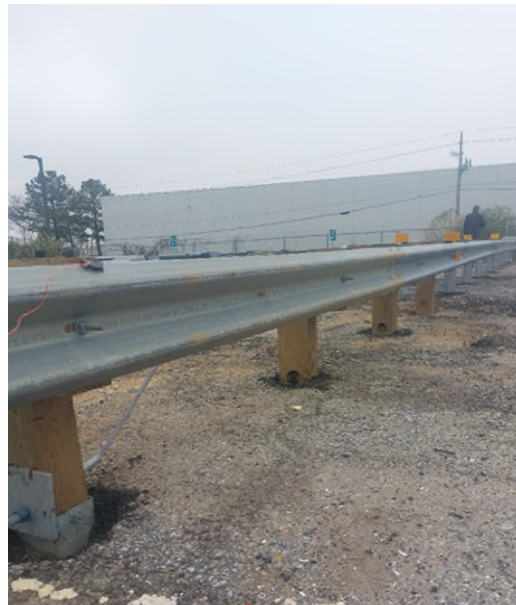
FLEAT-MT Inspection Checklist
	17. Do the CRT posts at locations 3, 5, 6, and 7 have two 3-1/2" breakaway holes located parallel to the roadway with the center of the top hole located at the ground line?

CRT posts at locations 3, 5, 6 and 7 have two 3-1/2" breakaway holes (checked prior to installation) located parallel to the roadway with the center of the top hole located at the ground line.

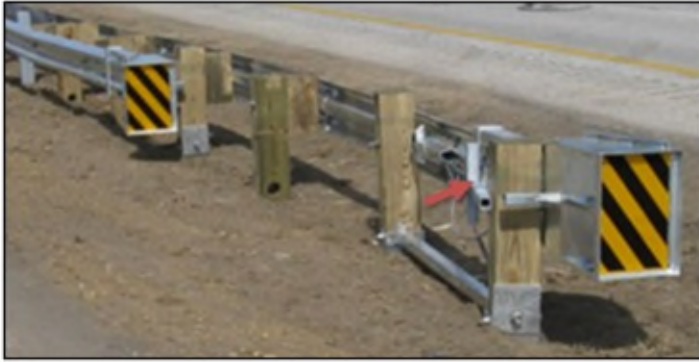
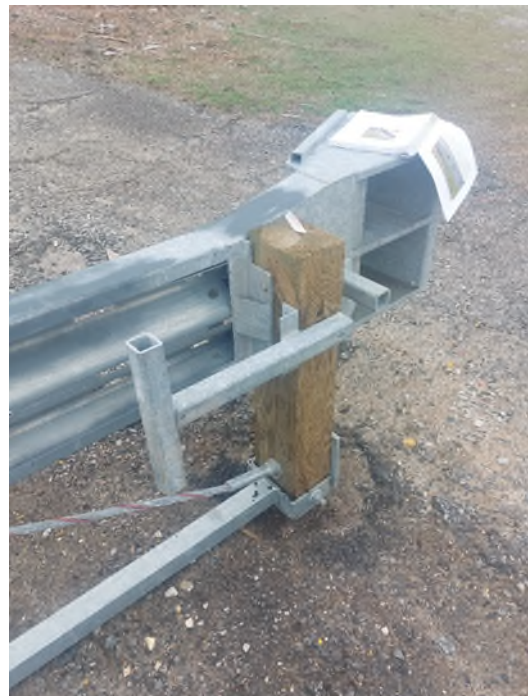
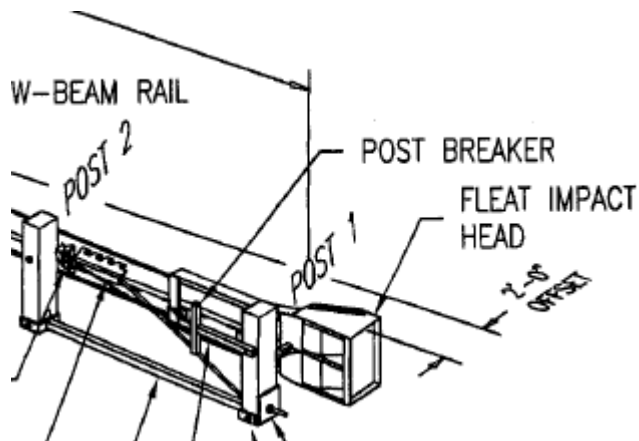
18. Is the post breaker attached at the non-traffic side of post #1 with two lag screws?

The post breaker is attached at the non-traffic side of post #1 with two lag screws.

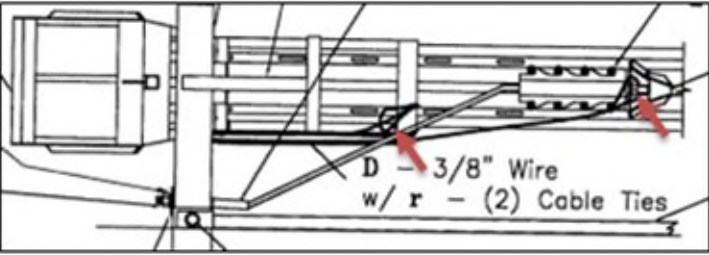
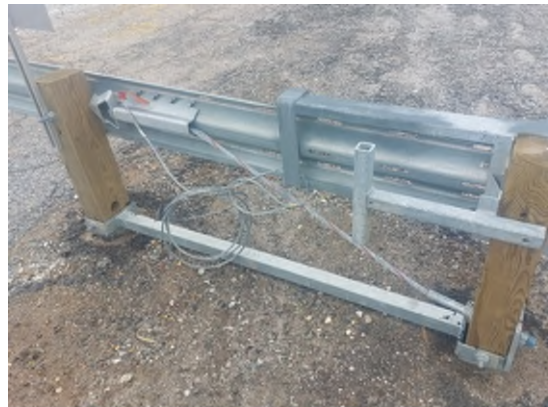
19. Is the 3/8" tether cable correctly looped around the impact head post #1, looped around the anchor cable near post #2, and tied under the impact head at post #1?

The 3/8" tether cable is correctly looped around the impact head at post #1, looped around the anchor cable near post #2, and tied under the impact head at post #1.

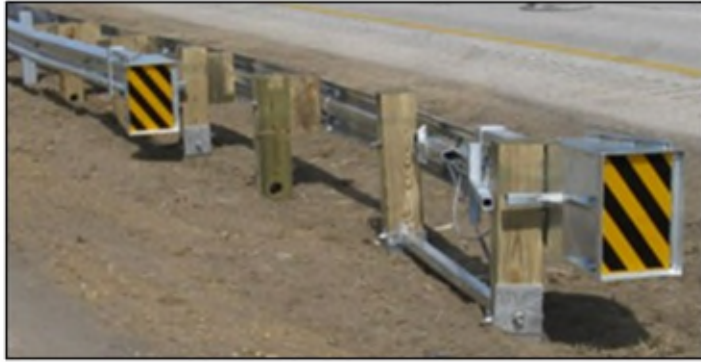
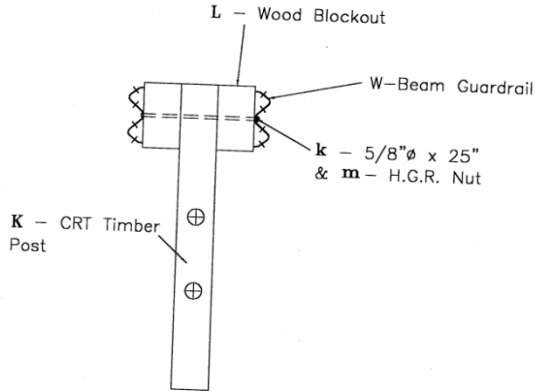
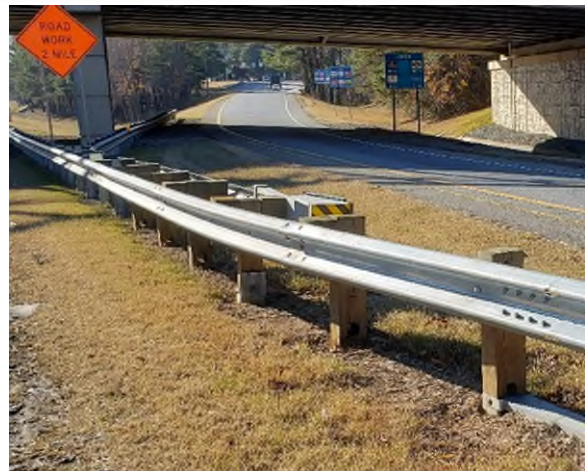
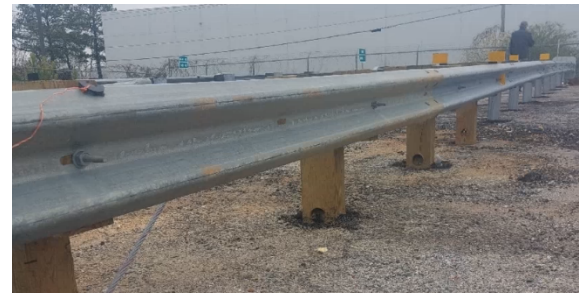
20. Are washers used on the face of the rail apart from the cable anchor bracket bolts?

No washers are used on the face of the rail except at the cable anchor bracket bolts.

Are the bolts the correct length? 25"
